2025

HELP Global Report on Water and Disasters

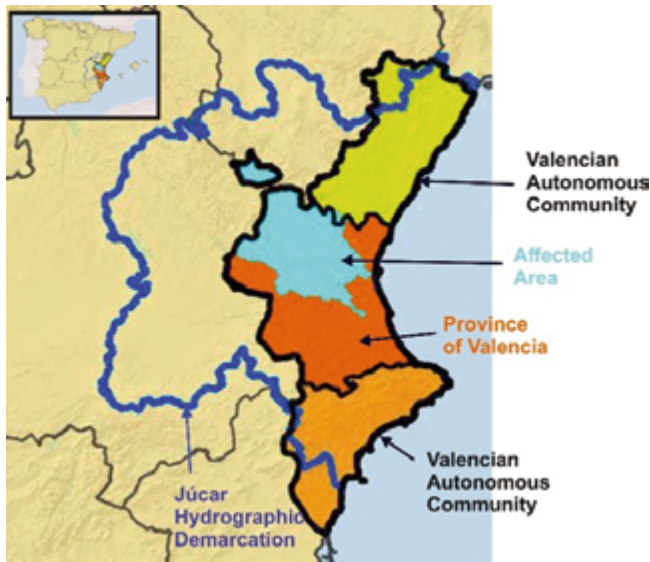
Figure 1: Location of the Valencian Autonomous Community and affected area.

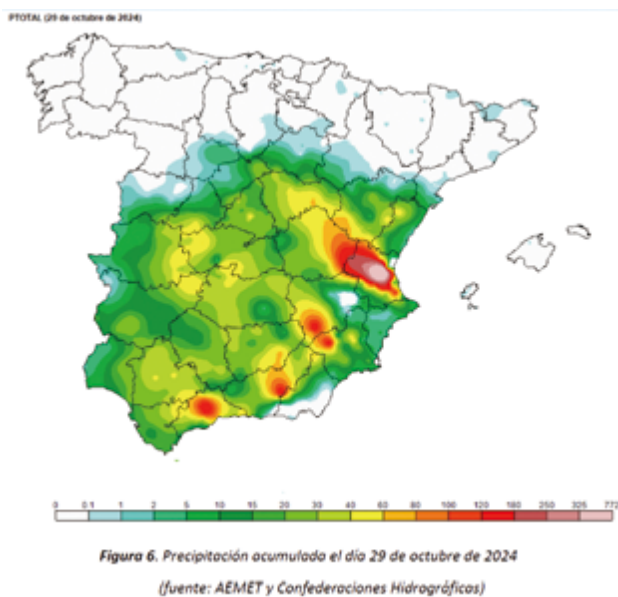
Figure 3: Accumulated precipitation on October 29, 2024. (Source: AEMET and River Basin Authorities).

As the figure illustrates, the highest values were recorded in the province of Valencia, but significant amounts also fell further southwest, in the provinces of Albacete, Murcia, Granada, and Málaga. Hereafter, we will focus only on what happened in the province of Valencia (229 fatalities including 3 people still missing), as the magnitude there was far greater than in the other provinces, where there were also 8 additional fatalities (7 in Castilla-La Mancha and 1 in Andalusia).

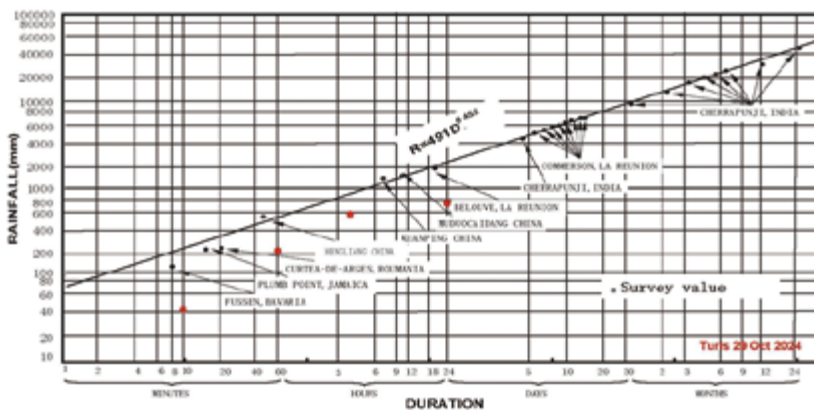
Figure 4: World's greatest known point rainfalls and their enveloping curve formula. (Source: WANG Guo-an, LI Bao-guo et al. 2026)

The maximum values recorded at the rain gauge in Turís, in the province of Valencia (AEMET station 8337X), are particularly significant, with the following measurements: 185 mm in 1 hour, 621 mm in 6 hours, 720 mm in 12 hours, and 772 mm in 24 hours, comparable to the world record values observed³ for rainstorms of durations ranging from 1 minute to two years, as can be seen in the following figure 4:

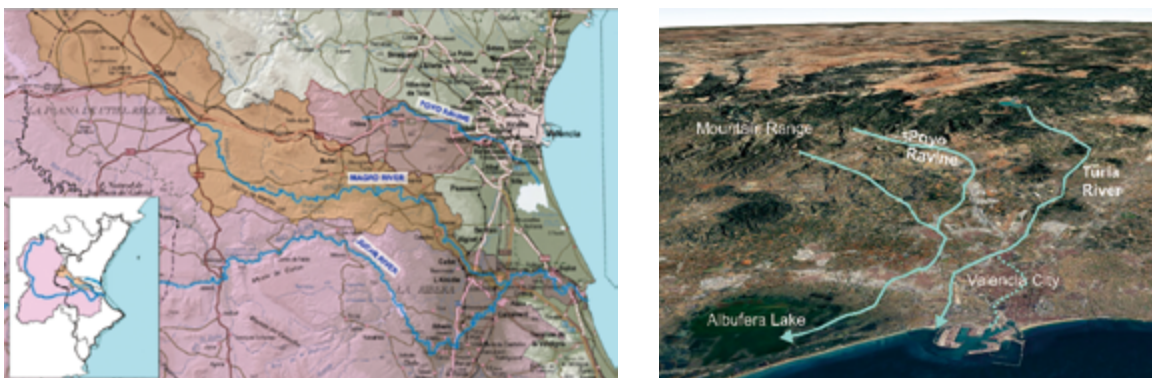
Figure 5: Geographical location of the affected basins.

In the province of Valencia, the main basins affected were those of the Poyo Ravine and the Magro River (a tributary of the Júcar), and to a lesser extent the lower section of the Turia River, which runs through the city of Valencia (figure 5). These basins are characterized as follows:

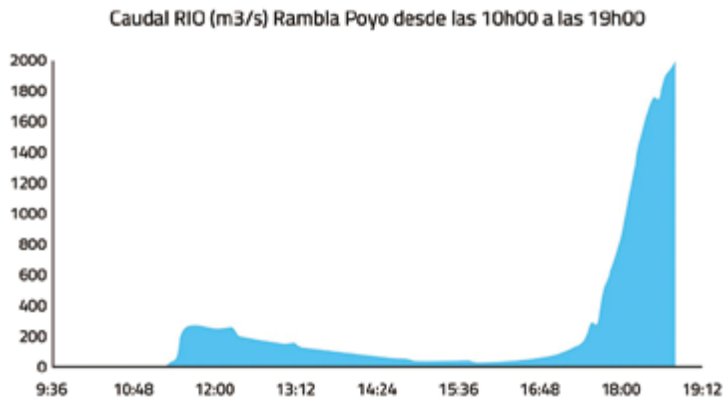
According to publicly available data from the CHJ, the hydrograph (figure 6) shows an initial peak of just over 200 m³/s at 11:30 a.m., which gradually declined until 17:00. At that time, a sharp surge occurred, with flows in the ravine rising to 2,000 m³/s in just two hours. At 18:55, the sensors ceased to function, as the bridge was overwhelmed by a violent flow laden with debris, including vehicles. Previous studies had estimated the 500-year return period flow for this basin at around 1,200 m³/s, meaning the observed flood far exceeded expected design thresholds.

Figure 6: River discharge (m³/s) – Poyo Ravine from 10:00 to 19:00. (Source: SAIH CHJ)

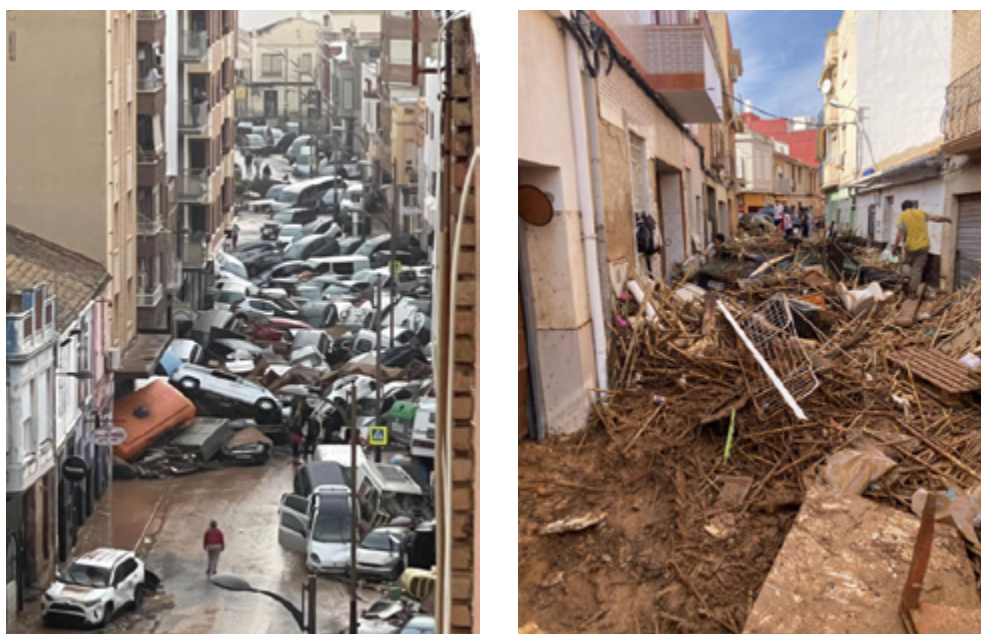
Figure 8: Damage caused in the town of Picanya.

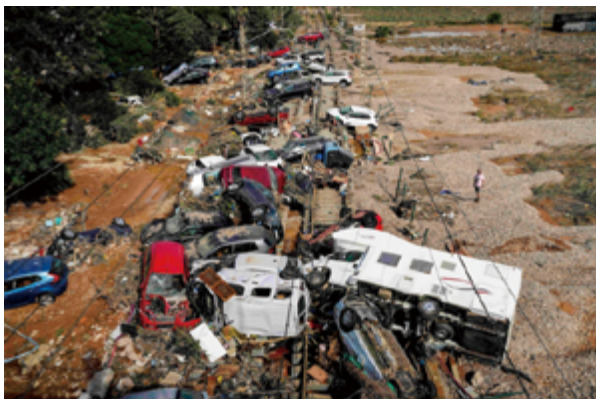
Figure 9 (left): Regional Railway Commuter Lines C1 and C2 in Alfafar.
 (Source: Manu Fernández (AP/LaPresse)).

- 229 fatalities (including 3 missing persons)⁵
- 306,000 people affected across 103 municipalities
- 11,242 homes damaged
- More than 10,000 elevators damaged, many still out of service, significantly restricting daily life for people with reduced mobility
- 124 public education centers affected (11% of the total in the province of Valencia)
- Severe damage to health infrastructure: 61 health centers, 3 hospitals, 8 day-care centers, and 101 veterinary clinics
- More than 64,000 businesses affected: 78% in the services sector, 12% in construction, 8% in industry, and 2% in agriculture
- 140,000 vehicles damaged (85% declared total loss) (figure 8)
- 803 km of roads, 560 km of railways (figures 9 and 10), and 380 bridges and culverts affected
- Total economic impact: 17,800 million €

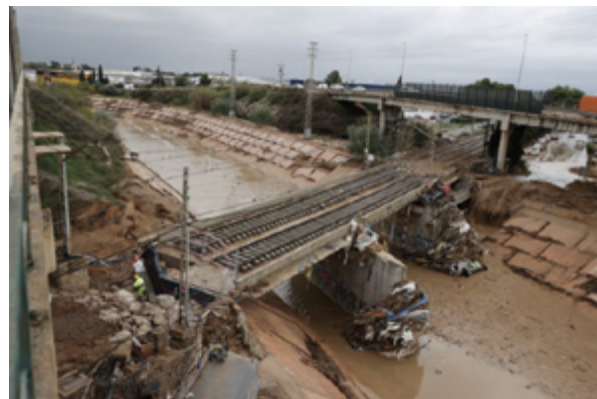
Figure 10 (right): Regional Railway Commuter Lines C1 and C2 in Massanassa.
 (Source: Manuel Bruque (EFE, El País))

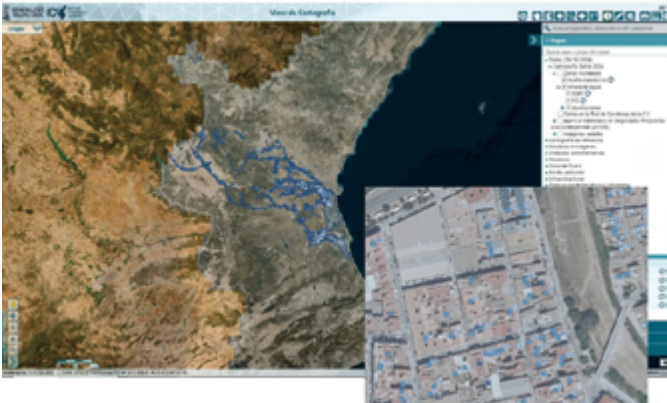
From a technical standpoint, in the weeks following the event, all available data were collected and processed, allowing for a very precise definition of the flooded area and the water depths observed at numerous locations, as shown in the following figure 11 taken from the GIS Viewer of the Generalitat Valenciana⁷.

Figure 11: GIS Viewer of the Generalitat Valenciana

Using this data, the Júcar River Basin Authority (CHJ) developed a 3D simulation model with sediments that faithfully reproduces what occurred. This tool has been extremely useful in guiding design decisions during the reconstruction process. In summary, more than 552 km² were directly affected, of which 63 km² correspond to urban areas and 489 km² to non-urban areas.

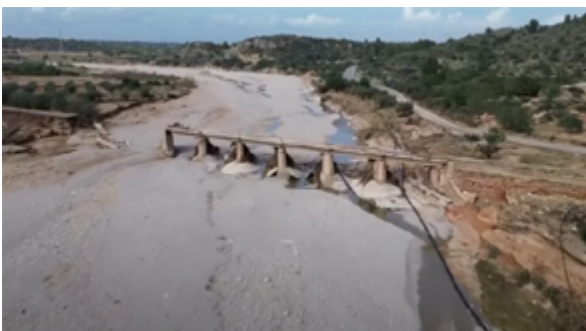
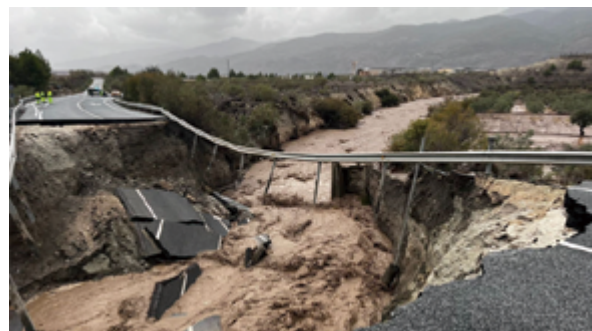
Figure 13 (left): Bridge of the Regional Commuter Railway Line C3 in Cheste. (Source: MITECO)

- The Ministry of Transport is responsible for rebuilding 36 local infrastructures damaged by the DANA across nine municipalities in Valencia (figures 13 and 14).

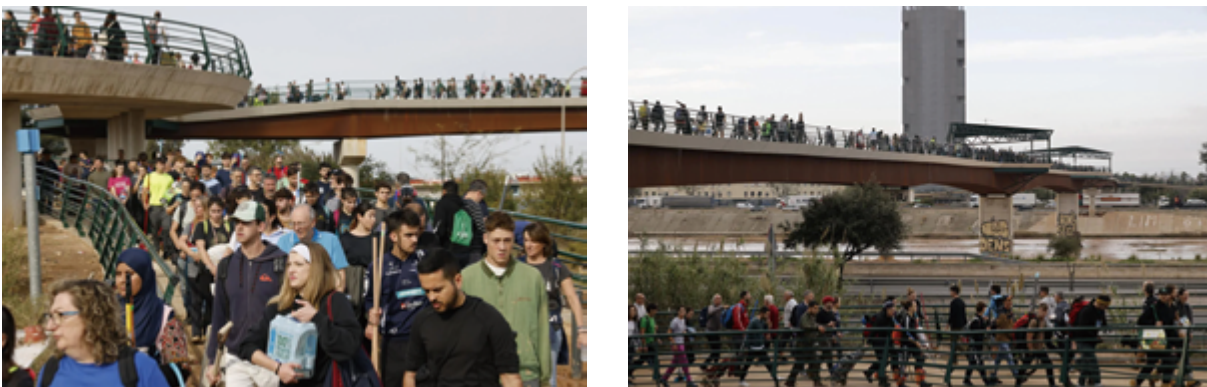
The contrast was striking, just 300 meters across the South Plan (Plan Sur) lay the unaffected city of Valencia, where daily life continued as normal. One pedestrian bridge across this channel, linking the neighborhoods of San Marcelino and La Torre, became the symbolic entry point for thousands of volunteers heading on foot each day to assist the flooded communities. In recognition of this extraordinary show of solidarity, the City Council of Valencia has named it the “Bridge of Solidarity.”

Figure 18: “Bridge of Solidarity over the Turia river”

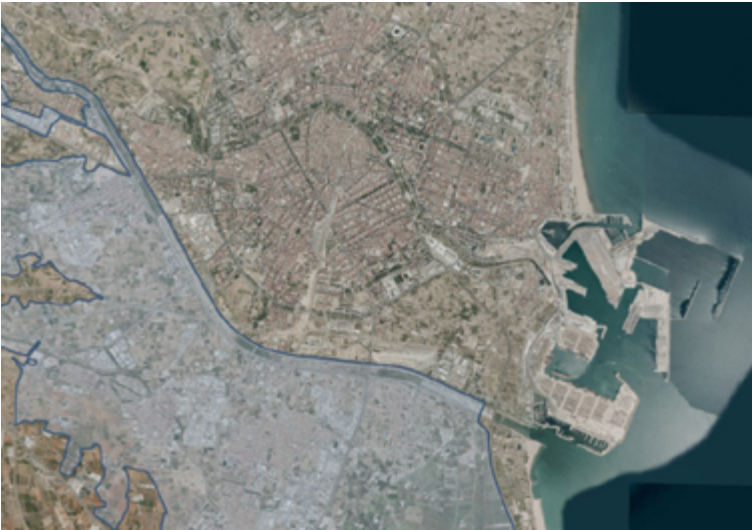
On the other hand, the South Plan (Plan Sur) infrastructure also acted as an unintended barrier for certain flood runoffs in the southern flooded area (Saleta Ravine). As shown in figure 19, these flows could not follow their natural drainage path to the sea, since the old channel was blocked by the construction of the South Plan. Instead, the waters ran parallel to the right bank of the new channel, causing severe damage and significant loss of life in the urban areas they encountered - particularly in the districts of Valencia known as the *Pedánias del Sur* (Southern Outlying Neighborhoods).

Figure 19: South Plan (Plan Sur) infrastructure also acted as an unintended barrier for certain flood runoffs in the southern flooded area (Saleta Ravine)

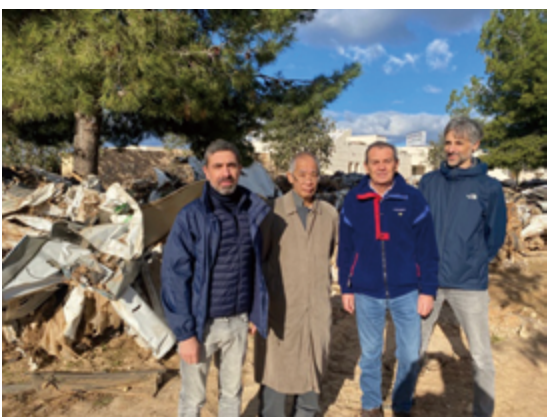
Figure 20 (left): Damaged vehicle depot in the Alfafar industrial estate. (Source: JL. Martin-Bordes)

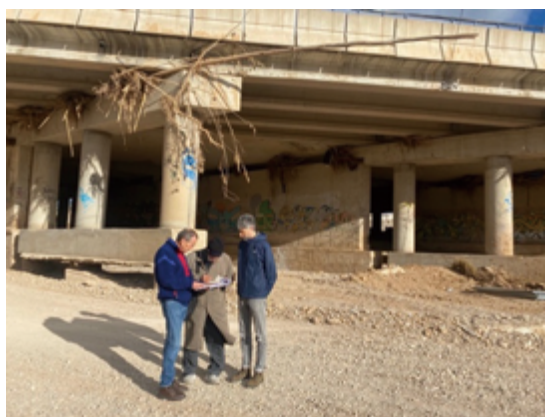
**Figure 21 (right): In the Poyo riverbed, under the A3 highway bridge:
location of the SAIH Júcar flow-gauging station. (Source: JL. Martin-Bordes)**

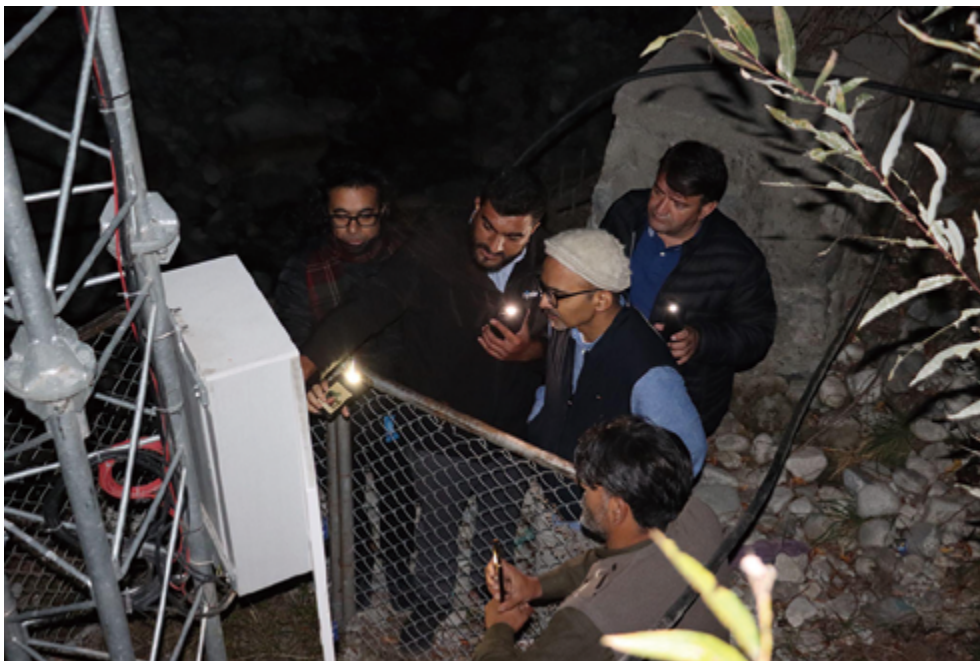
Figure: Newly set-up AWS for flood forecasting in Gilgit (2025) under GLOF II project

Once implemented (target by 2027), this project should significantly enhance Pakistan’s ability to see disasters coming and respond in time. For example, with additional radars and gauges, PMD will monitor rainfall and river flows in near real-time across the country’s river basins – enabling more pinpoint warnings. The modeling upgrades are expected to produce flood inundation maps up to 10 days in advance for major rivers, identifying which villages are likely to flood so evacuations and defenses can be planned precisely. For communities, the goal is that every at-risk person receives alerts (via siren, SMS, or local volunteer) well before floodwaters arrive. In quantitative terms, the project aims to cut the warning dissemination time down to <30 minutes (currently it can take a few hours for district warnings to propagate to all villages). Additionally, by analyzing historical data, the FEWS will help refine trigger thresholds for forecast-based action – linking with the kind of anticipatory financing described above.

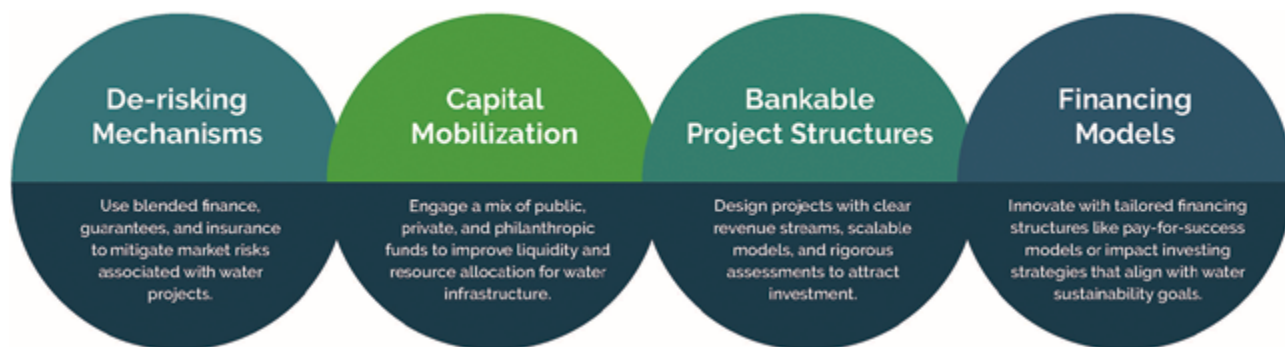
Figure: Financing mechanism to de-risk the market (Fakhruddin, 2025)

Pakistan is pursuing innovative blended-finance strategies to fund its climate-resilience and water-sustainability goals. A core approach is to de-risk projects through concessional finance, guarantees, and insurance to mitigate market risks in water and flood management. For example, the Green Climate Fund (GCF) provides grants and first-loss equity that blend with private capital, effectively insuring investors against initial risk and attracting co-financing. GCF has approved \$304 million across ten projects in Pakistan – including the \$77 million Recharge Pakistan ecosystem-based flood management plan – largely structured as grants or low-interest loans to de-risk large-scale adaptation investments. This concessional funding serves as an anchor, giving commercial lenders confidence through guarantees or senior-junior capital structures. Pakistan's climate financiers are also exploring parametric insurance (e.g. under the G7's Global Shield initiative) to provide automatic payouts when extreme flood thresholds are exceeded, again reducing risk for both communities and investors by ensuring liquidity during disasters.

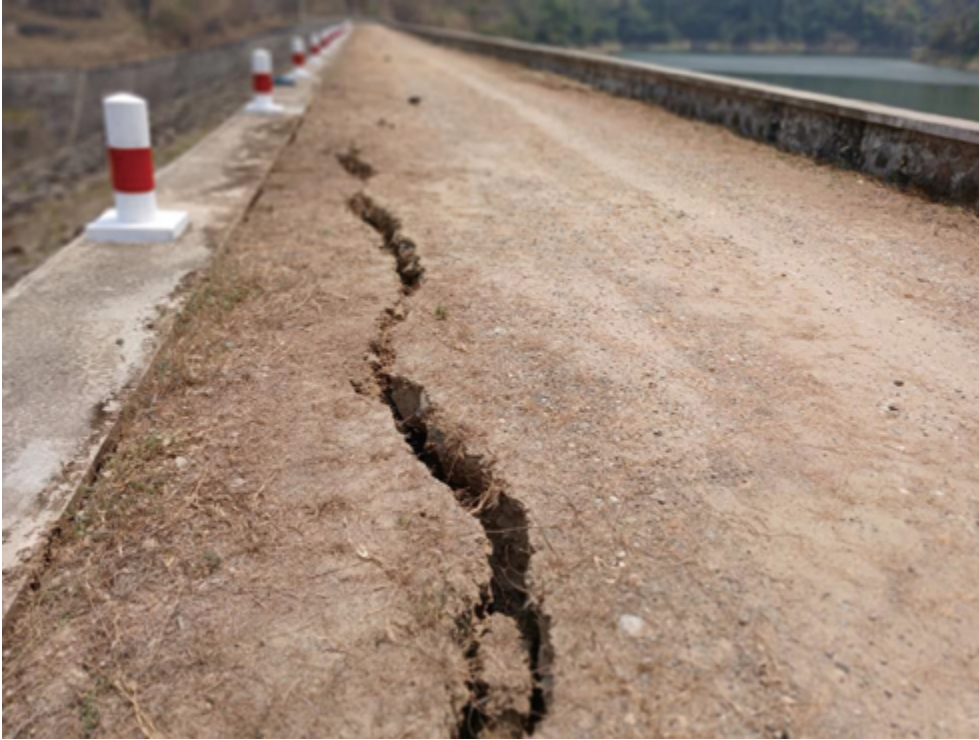
Fig. 9: Phyu Chaung Dam Longitudinal Crack on the Dam Crest (R.D 700 ft)

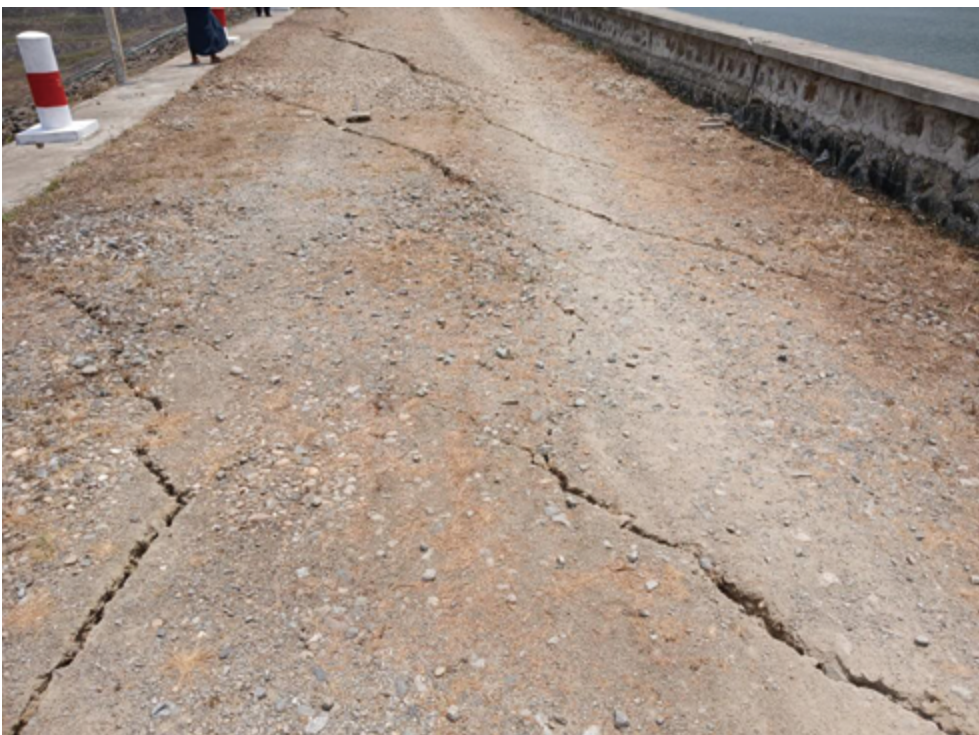
Fig. 10: Phyu Chaung Dam Diagonal cracks at the Dam Left End (R.D 50 ft)

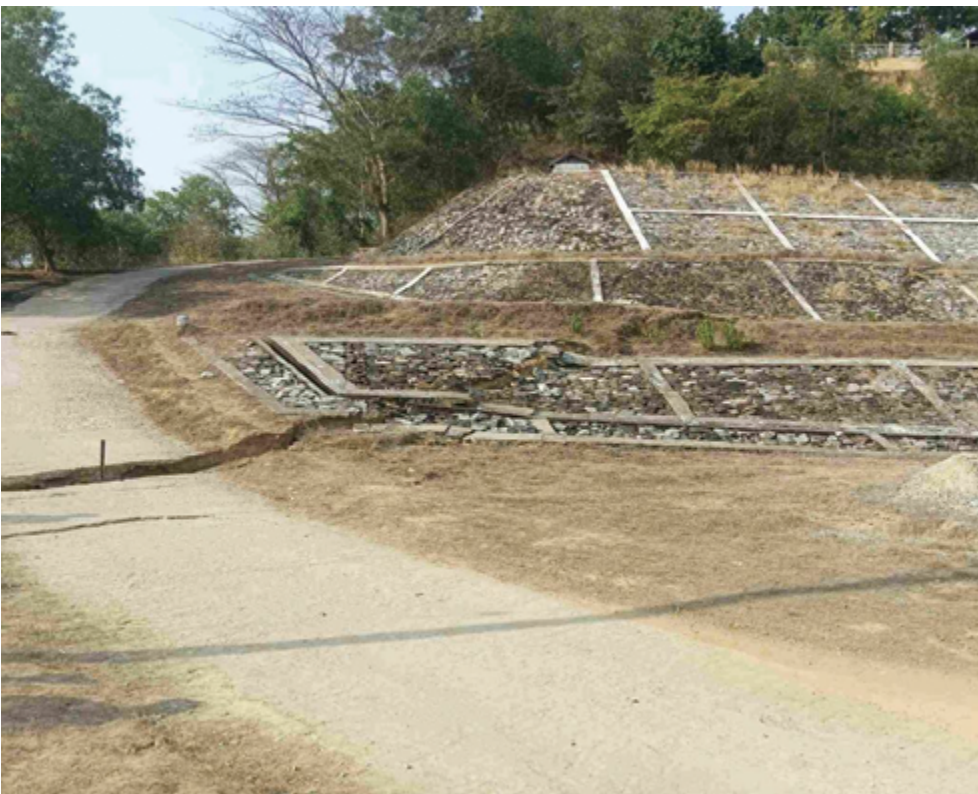
Fig. 11: Ye Nwe Dam Crack Line at the Left Abutment

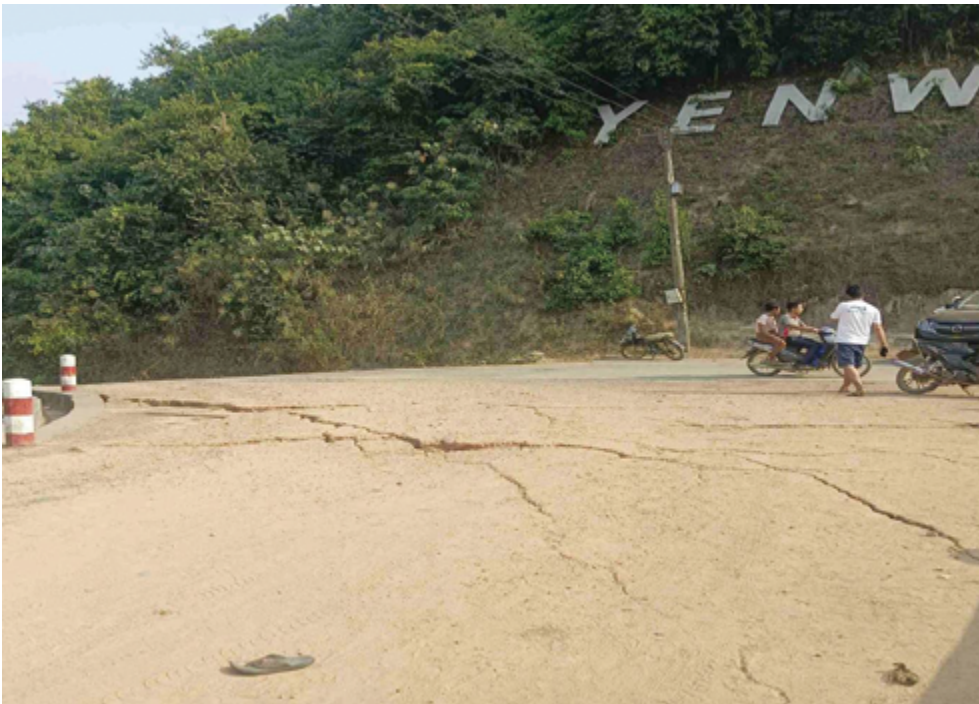
Fig. 12: Ye Nwe Dam Crack Line at the Right Abutment

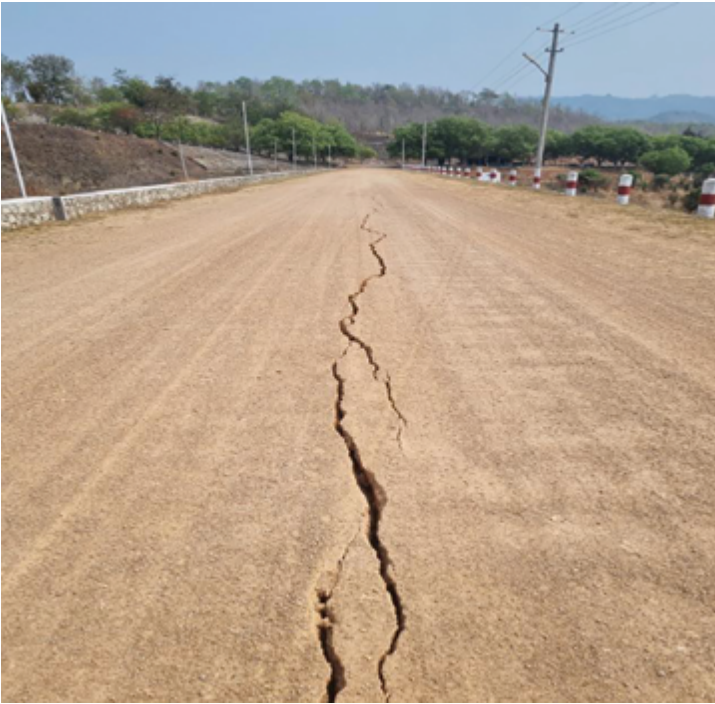
Fig. 13: Lower Paunglaung Dam Longitudinal Crack on the Dam Crest

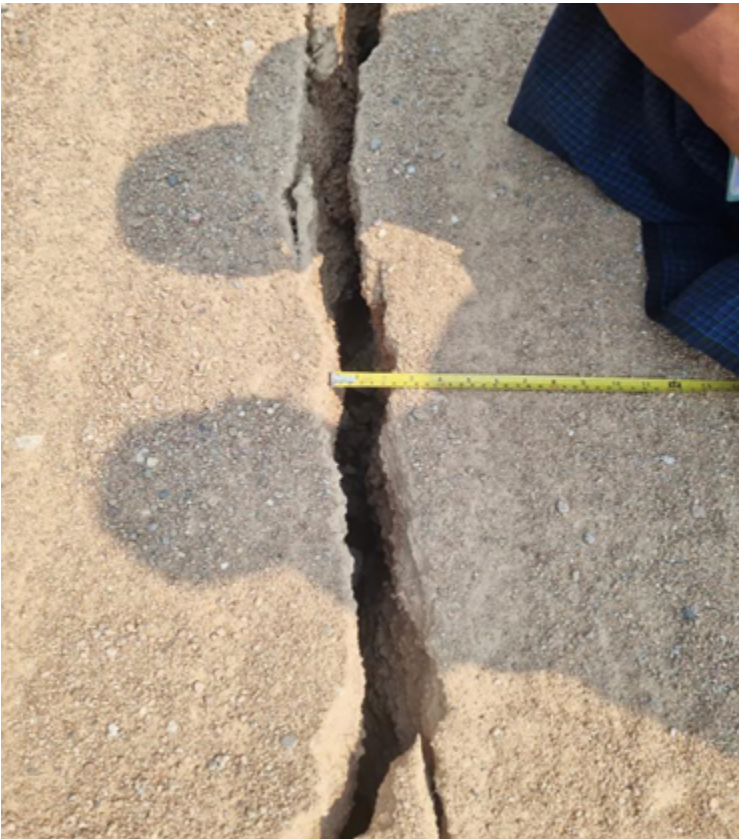
Fig. 14: Lower Paunglaung Dam Measuring Width of Crack Line

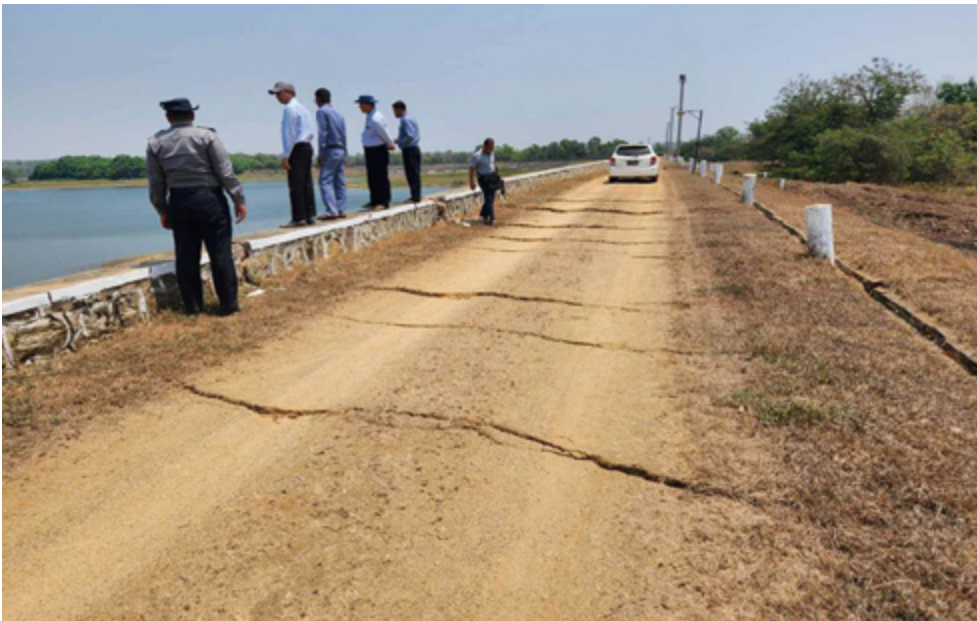
Fig. 15: Chaungmagyi Dam Transverse Crack Lines at R.D 3800 ft

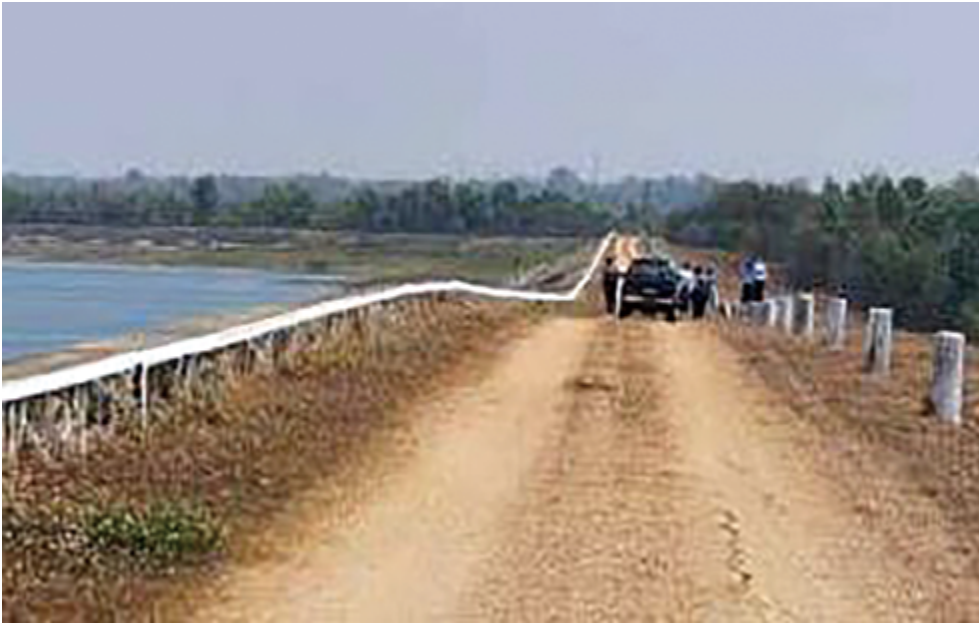
Fig. 16: Chaungmagyi Dam Differential Settlement of Dam Crest at R.D 5000 ft

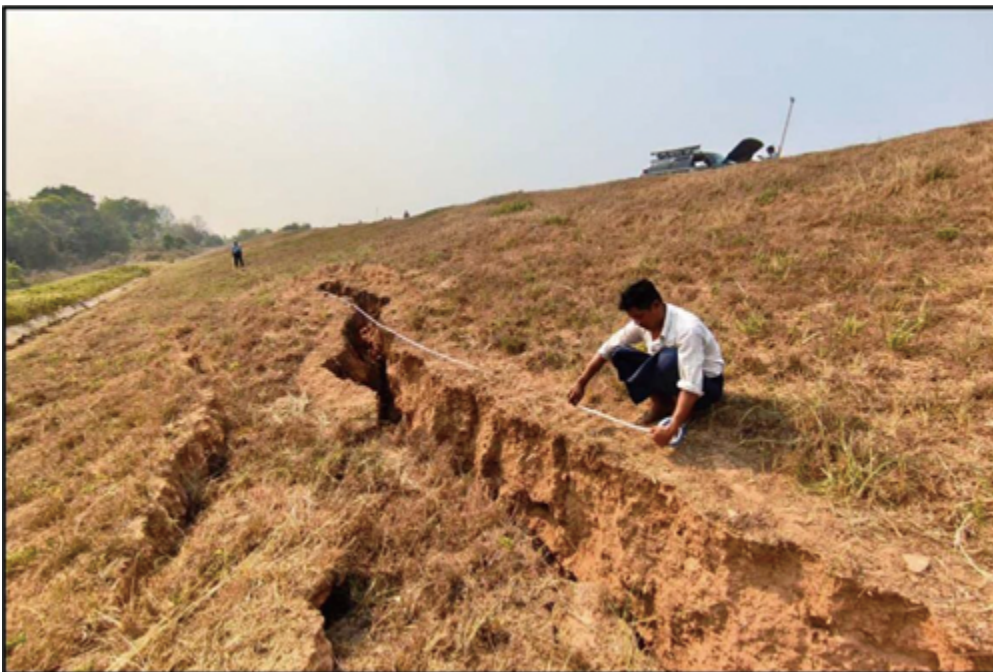
Fig. 17: Chaungmagyi Dam Longitudinal Crack Line on the Dam Downstream Face at R.D 4200 ft

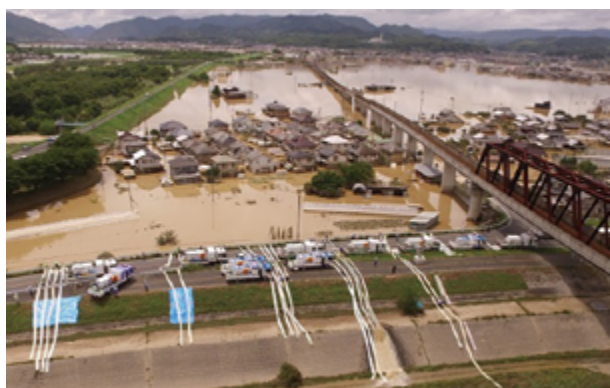
Figure 3. Emergency Drainage Using a Drainage Pump Truck

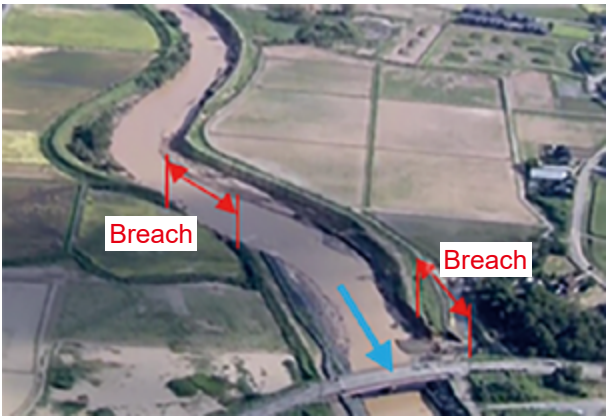
Figure 10. Breach of the Machinogawa River system's embankment (Wajima City, Ishikawa Prefecture)

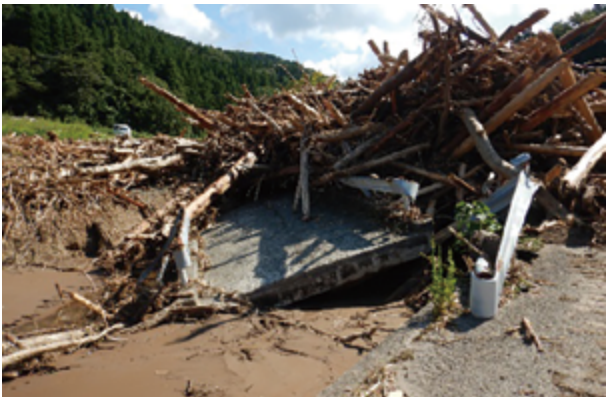
Figure 11. Sediment and driftwood accumulate in the Tsukada River system (Wajima City, Ishikawa Prefecture)

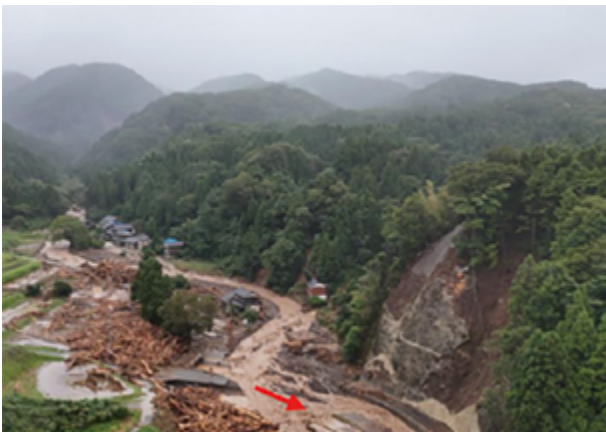
Figure 12. Debris Flows and Other Related Incidents in Kute River Town, Wajima City, Ishikawa Prefecture

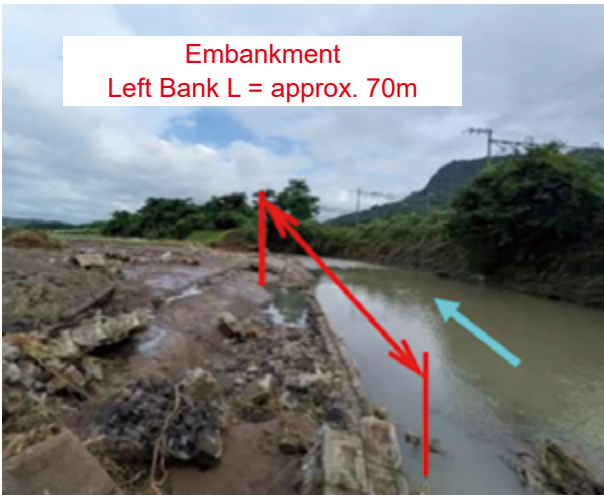
Figure 14. Restoration Works for the Kiba River within the Kikuchi River System (Tamato Town, Kumamoto Prefecture)

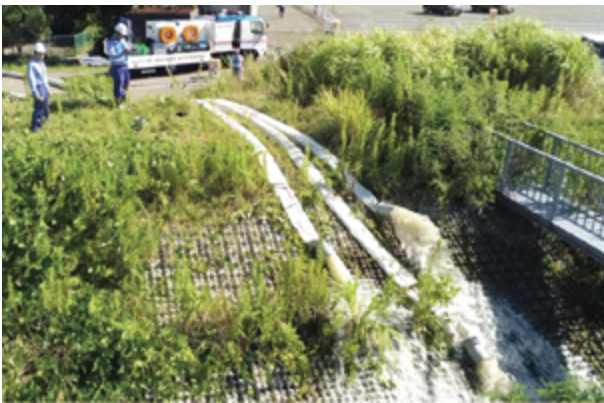
Figure 15. Drainage Support Using Drainage Pump Vehicles for Inland Water Removal (Kanagawa City, Ishikawa Prefecture)

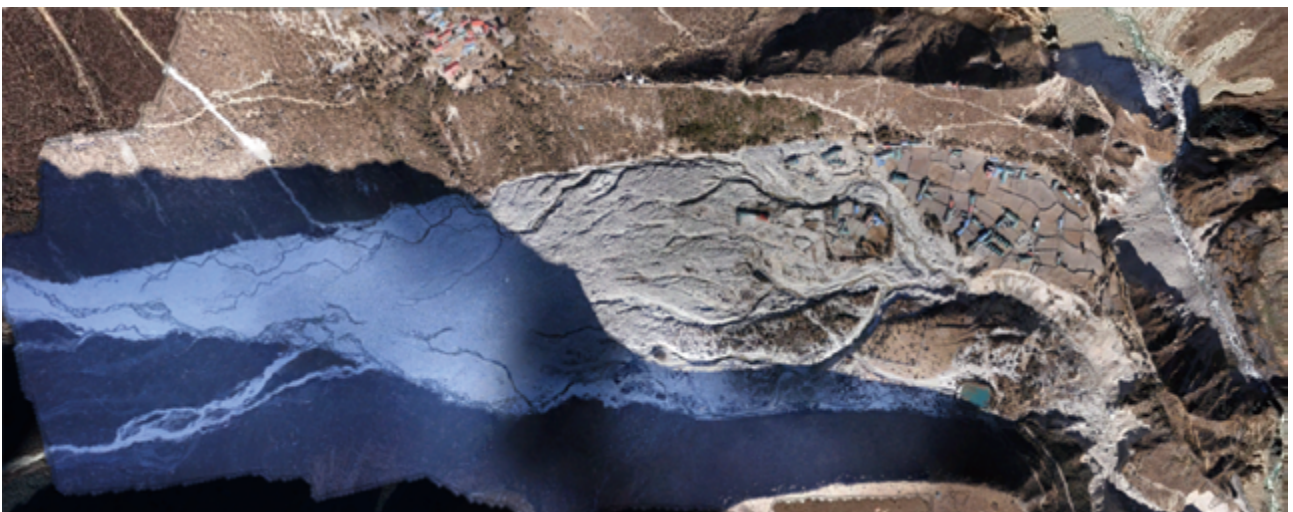
Figure 6: Map (background Image source: Planet) of the Thame valley showing glaciers and glacial lake with two breached glacial lake highlighted by red polygon (GL-5 in the mid-left is Upper Ngole Cho and GL-4 is Lower Ngole Cho) (Top) . Uncrewed Aerial Vehicle (UAV) captured image (Yellow rectangular mark in top image) showing the impact of GLOF in Thame village (Bottom).

identifies eight glacial lakes within the watershed, ranging from 0.001 km² to 0.12 km², of which some are locally named while others remain unnamed. Among these, the Upper Ngole Cho and Lower Ngole Cho lakes which lie around 10 km above the Thame village were the ones that failed, setting off the chain of events leading to the flood (Figure 6).

Field investigations, coupled with remote sensing analyses, indicate that a rock avalanche from the left flank of Upper Ngole Cho triggered the initial breach. The avalanche, with an approximately 200-meter fall, generated a high-energy displacement wave that overflowed through the lake's outlet causing significant erosion of the moraine deposits atop of the bedrock. The section of the dam eroded measures 4.5 meters in thickness and 20.7 meters in width (Figure 7). This failure released approximately $1.56 \times 10^5 \text{ m}^3$ of water from the lake and a 20% reduction in its surface area (Maharjan et. al. 2025a).

The overflowing water then descended roughly 120 meters and gained tremendous erosive power and surged towards the downstream Lower Ngole Cho. This increased pressure, combined with the erosive force of the high-velocity flow, rapidly weakened the structurally unconsolidated moraine of Lower Ngole Cho. As the floodwater continued to erode the moraine, it eventually failed, resulting in a breach measuring 21.6 meters in depth and approximately 51 meters in width (Figure 7). This led to the release of roughly $3.03 \times 10^5 \text{ m}^3$ of water leading to a substantial decrease of around 60 % of the lake's total surface area.

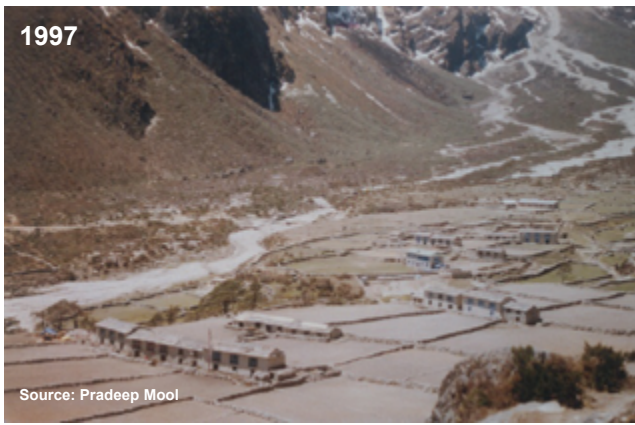
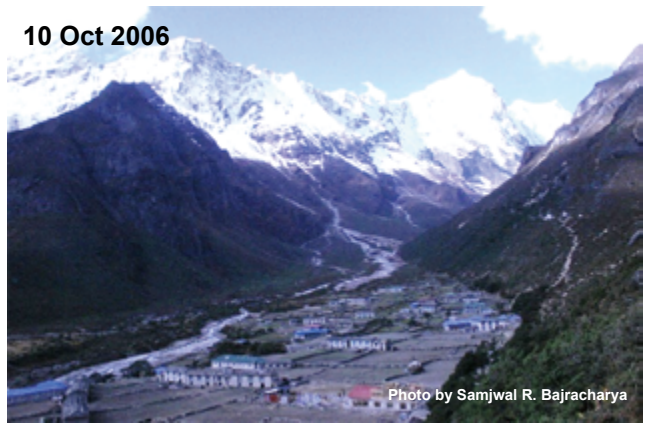
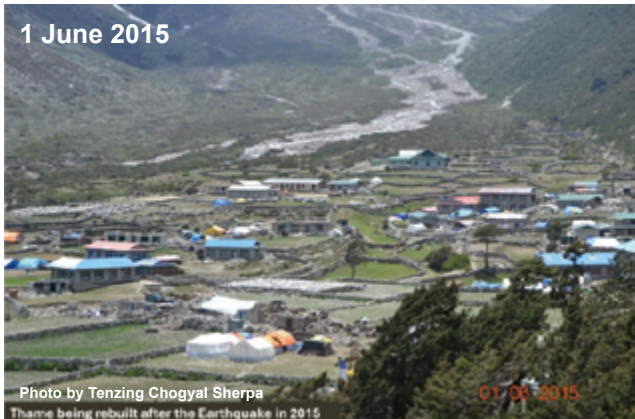
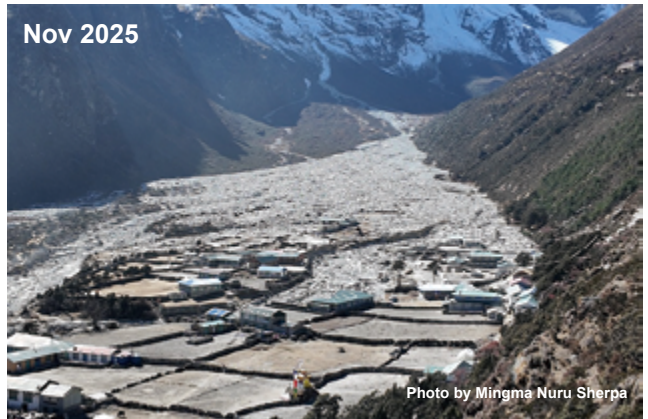
Figure 8: Time lapse photographs showing development of Thame village over time and impact by the 2024 GLOF.

These processes caused severe destruction in the village: 24 households were completely damaged, 14 were partially damaged, and 16 experienced minor damage. Among the damaged houses were eight hotels and lodges and several small businesses. A total of 9.51 hectares of agricultural land was heavily affected. Thame School, the village's only school was destroyed (Figure 8 and Figure 9). The intake of the hydropower operated by the Khumbu Electricity Company, which supplies electricity to Thame, Namche, Khunde and Khumjung was severely damaged, along with transformers, and electricity poles.

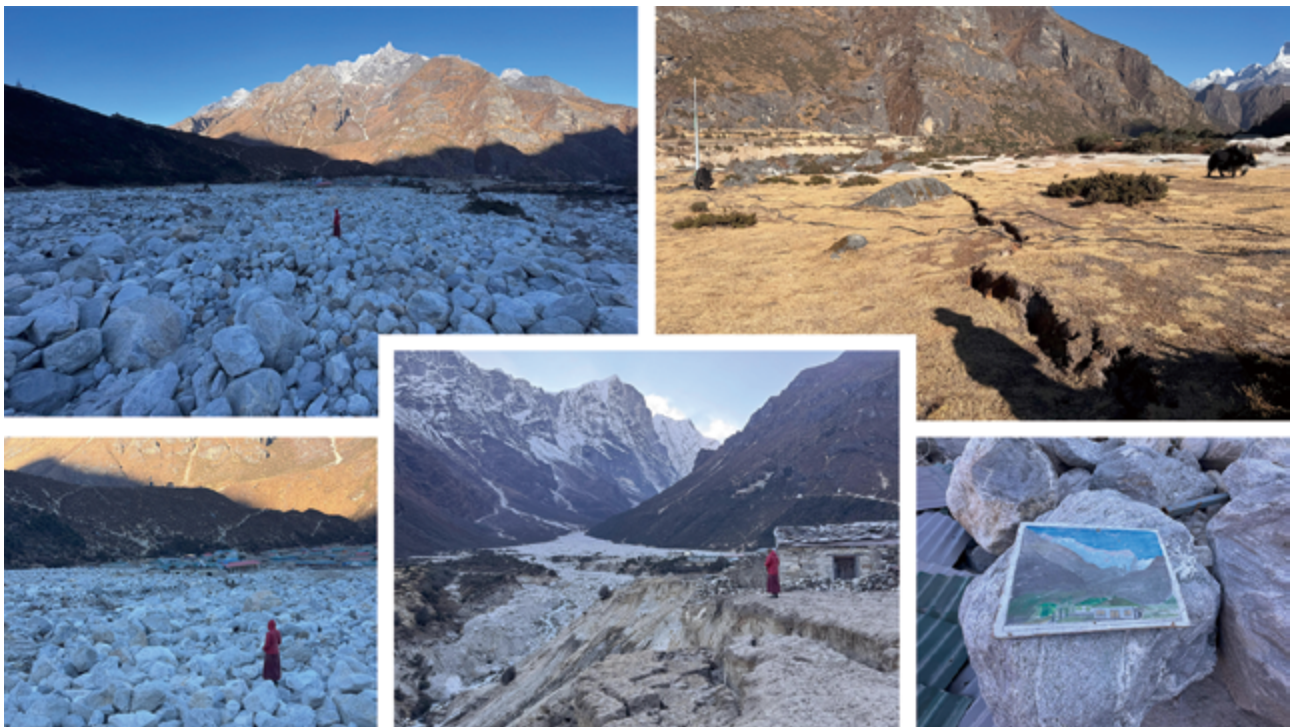
Figure 9: Post-GLOF landscape of Thame village, showing extensive boulder deposition, sediment accumulation, and active tension cracks. Photo: Tenzing Chogyal Sherpa

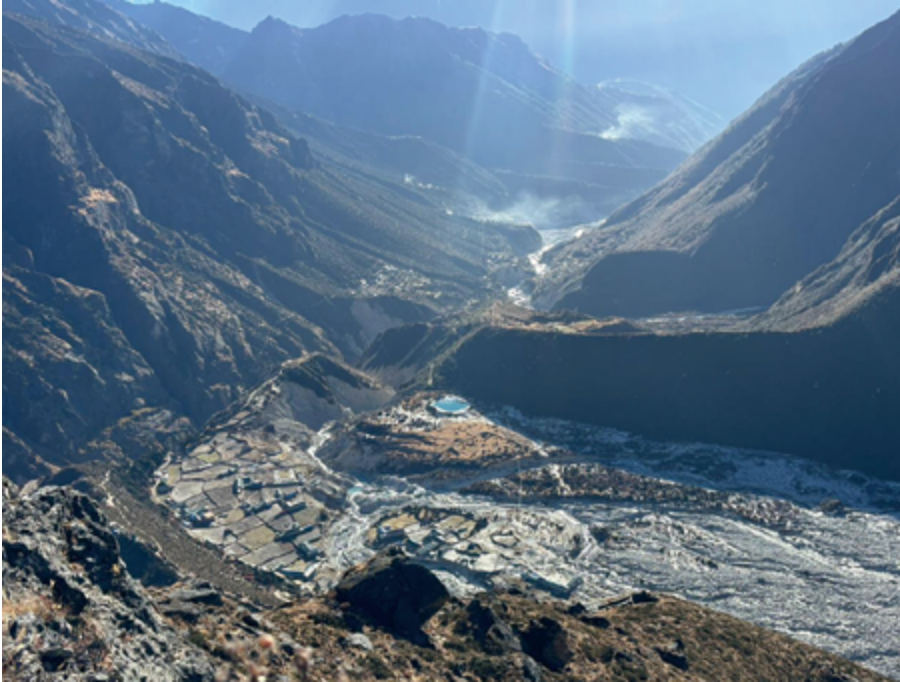
Figure 10: Overlooking the current state of Thame village as of November 2025.
(Photo by: Mingma Nuru Sherpa)

Concurrent to that, During the 2025 monsoon season, increased river discharge extensively eroded the sandy riverbank near the settlement. A section of the riverbank toward the settlement collapsed, temporarily blocking the channel before rapidly breaching and draining. This avulsion event swept away additional five houses that had survived the 2024 GLOF, underscoring the prolonged vulnerability of the area and the continuing impacts. At the same time, tension cracks along both riverbanks have continued to widen and deepen, causing progressive subsidence and the collapse of several bank sections. These failures are slowly encroaching toward the remaining parts of the village, placing what is left of Thame at persistent and increasing risk (Figure 10).

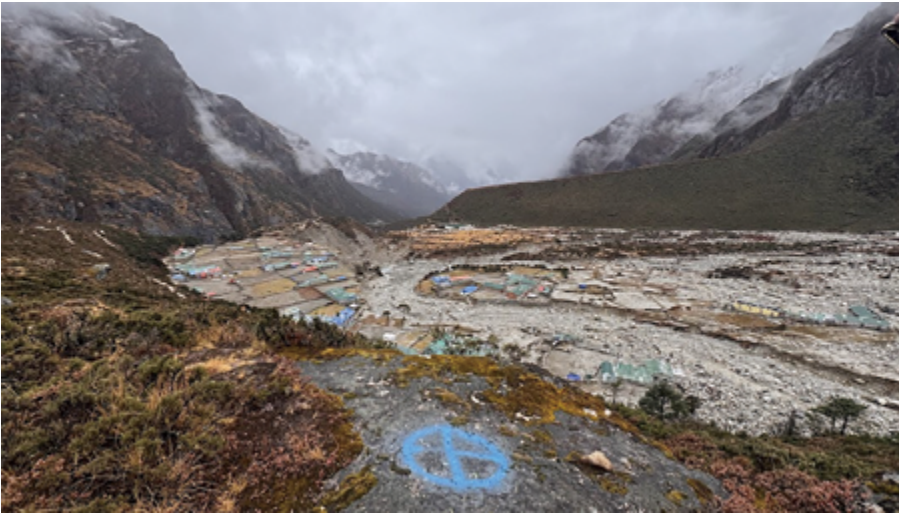
Figure 12: Field photograph of Thame village showing the proposed siren installation site, marked with a blue crossed circle on the upper left terrace of the village. (Photo: Tenzing Chogyal Sherpa)

Following the GLOF, the Sagarmatha Pollution Control Committee (SPCC), together with the Khumbu Pasang Lhamu Rural Municipality (KPLRM), took significant initiative. Recognising the urgency of improved preparedness, they began working closely with Sherpa researchers and technical professionals from the community. Through this collaboration, they secured funding for a flood early warning system for Thame Valley and the downstream settlements. The project is now underway and is expected to be completed within the next two years. Importantly, it stands to become one of the first early warning systems in the region that is locally initiated, locally led, and locally managed. Figure 11 and Figure 12 shows the location of selected sites for the installation of early warning systems including hydrological stations and automatic weather stations in Thame valley and beyond.

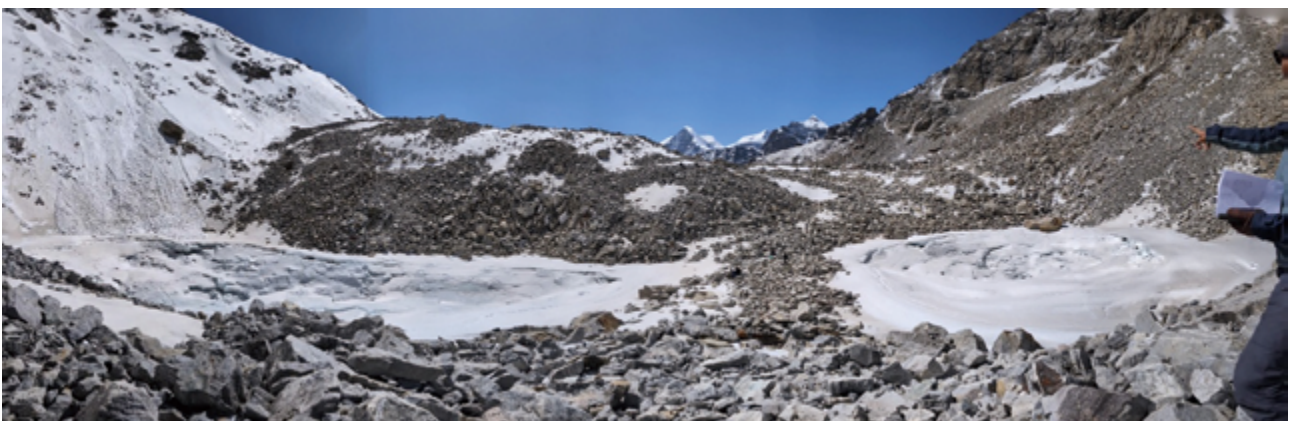
Figure 15: Field photograph showing two lakes with their frozen surfaces collapsed inward at the center, indicating that both lakes had fully drained. (photo by Sudan Bikash Maharjan)

Field photographs indicate that the surfaces of both lakes were frozen and had collapsed inward at their centers, confirming that the lakes had completely drained (Figure 15). During the field investigation, numerous subsurface drainage channels were observed carrying meltwater from snow and ice into the lake basins, as well as through the adjacent rock glaciers, accompanied by audible water flow. These observations suggest that, with the onset of the thawing season, melting snow and ice percolate into the porous rock debris, and their thermal influence accelerates the thawing of interstitial ice within the rock glaciers. This process channels lake water internally through the cascading rock glacier and results in its discharge was observed at 300m downstream from the lake near the base of the second rock glacier.
