2025

HELP Global Report on Water and Disasters

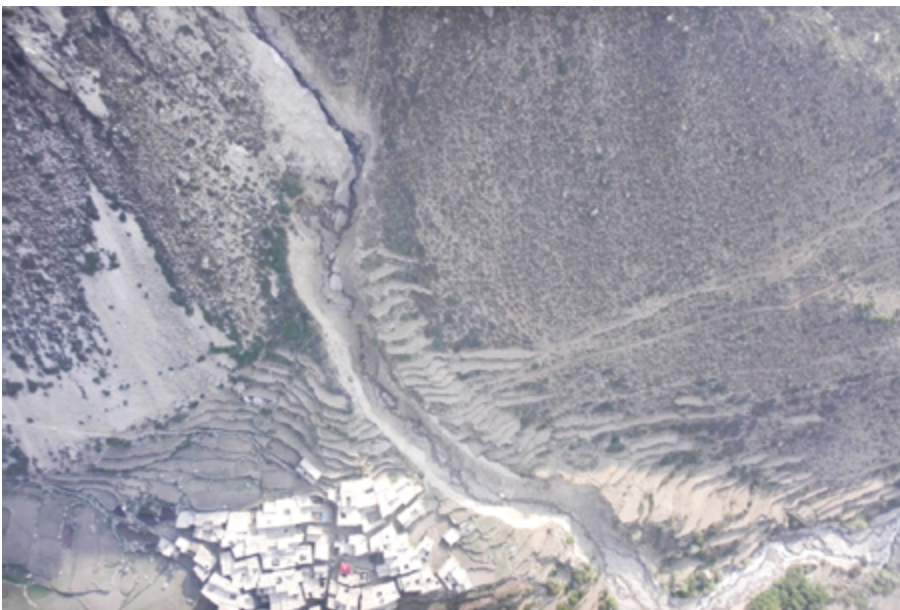
Figure 16: An aerial view captured by an Uncrewed Aerial Vehicle (UAV) shows a deeply incised drainage channel cutting through the rocky steep terrain in the upper section, with pronounced vertical and lateral erosion on the talus fan deposits in the middle and lower sections. Til village is visible in the lower left corner of the image.

The sudden drainage of the lake released a rapid surge of water downstream. However, this outflow did not trigger a collapse of the rock debris nor mobilize significant sediment from the moraine itself. Erosional activity began approximately 500 m downstream from the lake and evolved into a high-energy flow around 800 m downstream, where temporary ponding was more likely and the channel gradient increased. Beyond this point, the flow intensified further as it passed through a steep, high-gradient channel with numerous waterfalls and rapids, resulting in pronounced vertical and lateral erosion along its course.

The most significant and severe vertical erosion occurred near Til village, where the flow dropped abruptly from intact bedrock terrain onto the talus-fan deposits in the village area. Here, the riverbed was scoured to a depth exceeding 20 m, causing progressive bank failures and extending tension cracks that placed three residential houses, an animal shed, and a drinking-water tap at high risk (Figure 16 and Figure 17). It also washed out the village's drinking-water and irrigation systems, the trail connection between the village and the monastery, and the water-supply system for the local micro-hydropower plant. Additionally, the powerhouse of the under-construction 15 kW hydropower located further downstream was washout (Figure 18).

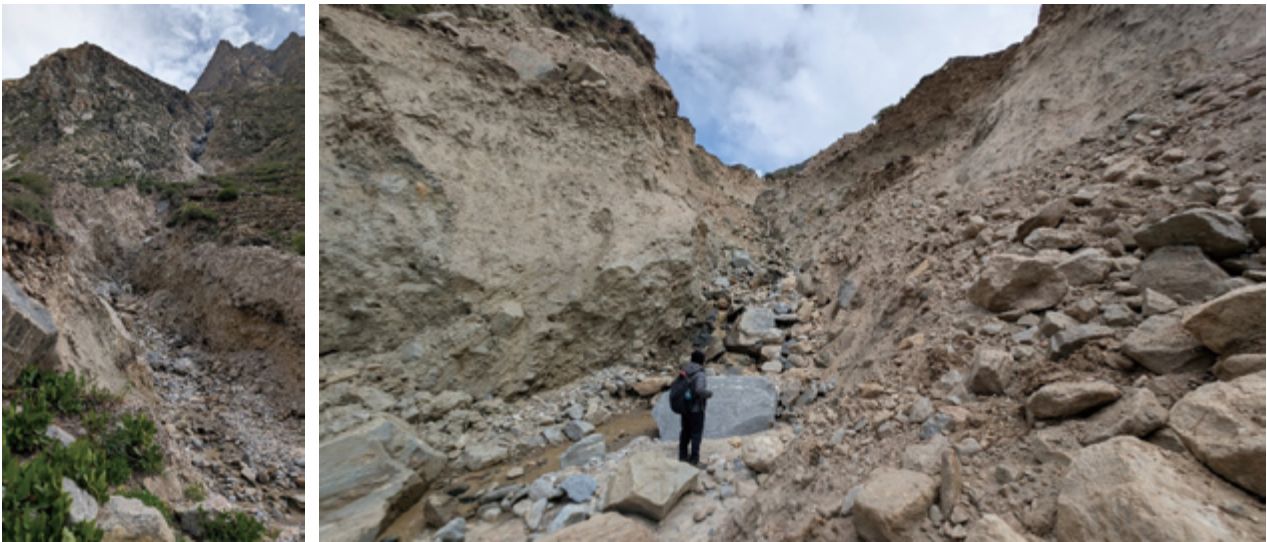
Figure 17: Field photographs showing deep vertical incision and erosion on the talus fan deposits, along with progressive bank failures to the east of Til village. (photo by Sudan Bikash Maharjan)

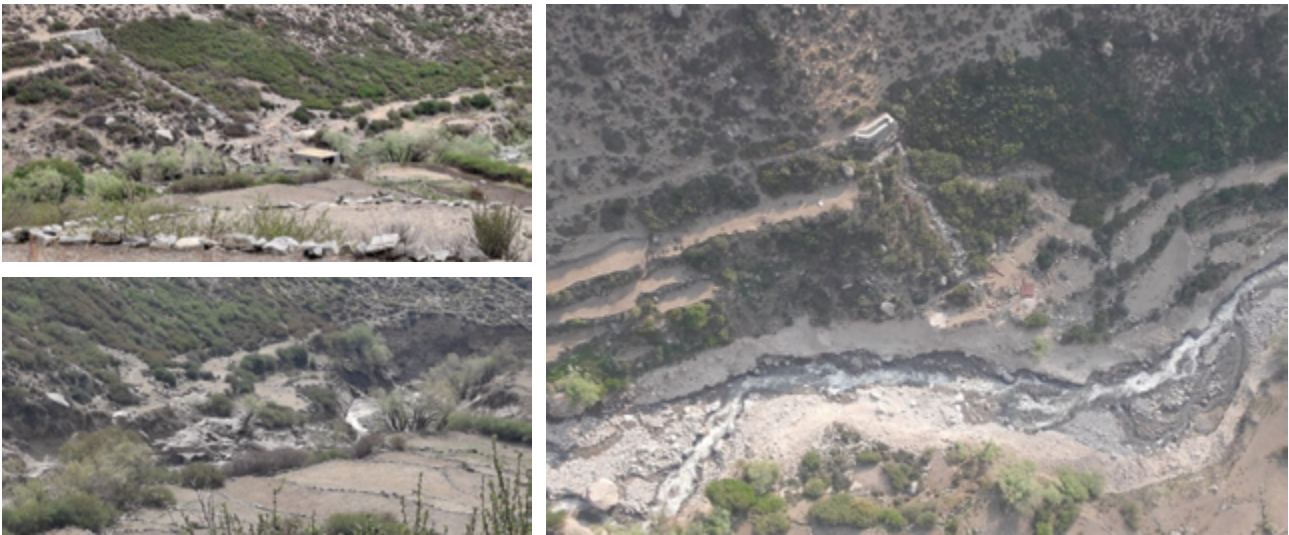
Figure 18: Pre- and post-event field photographs show the 15 kW hydropower station, which was under construction, completely washed out by the flood. (Left photo by Penpa Dhondup, Ward Member of Limi Rural Municipality; Right photo by Sudan Bikash Maharjan).

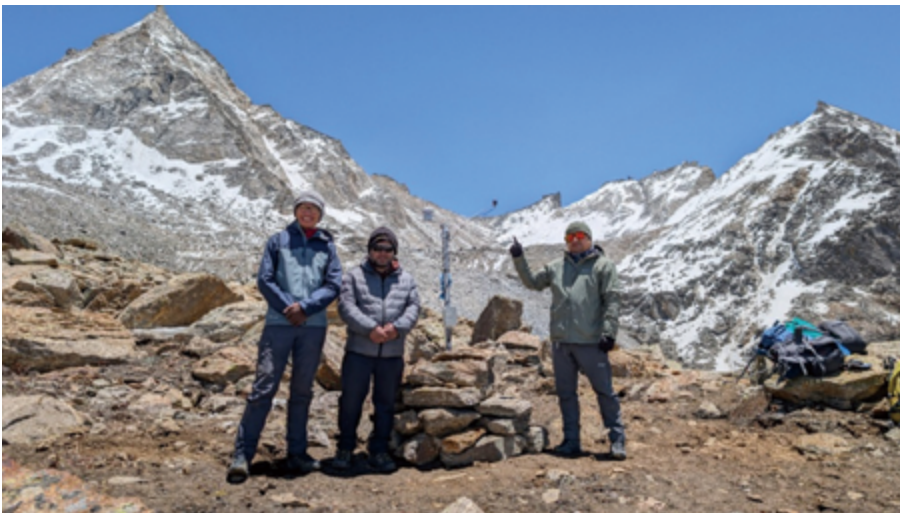
Figure 19: Micro-weather station installed near the lake drained area at 5,270 m asl, measuring relative humidity, air temperature, solar radiation, soil moisture, and soil temperature from 20 cm below ground up to 2 m above the surface in stable terrain.

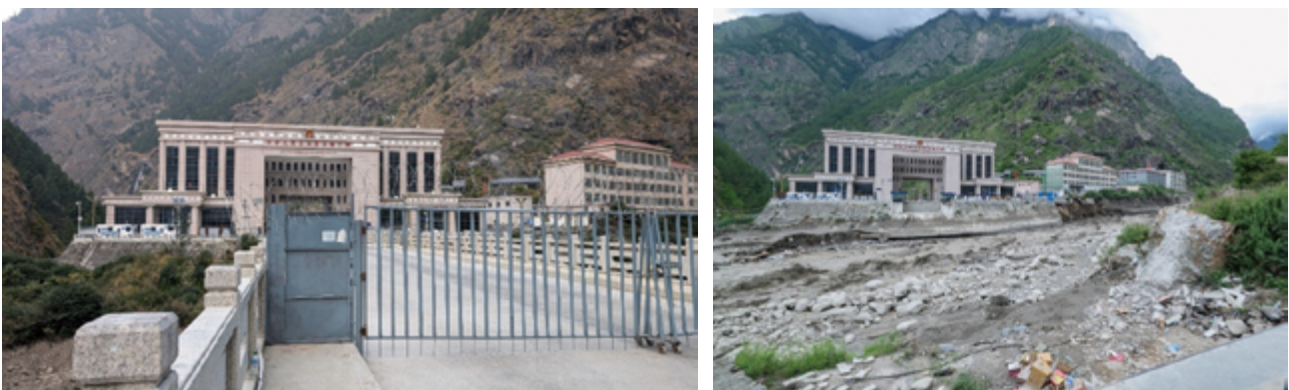
Figure 22: Before (November, 2024) and after (9 July 2025) photographs showing the Nepal-China Friendship bridge was completely wash out by GLOF. (Photo by Sudan Bikash Maharjan{left} and Online{right})

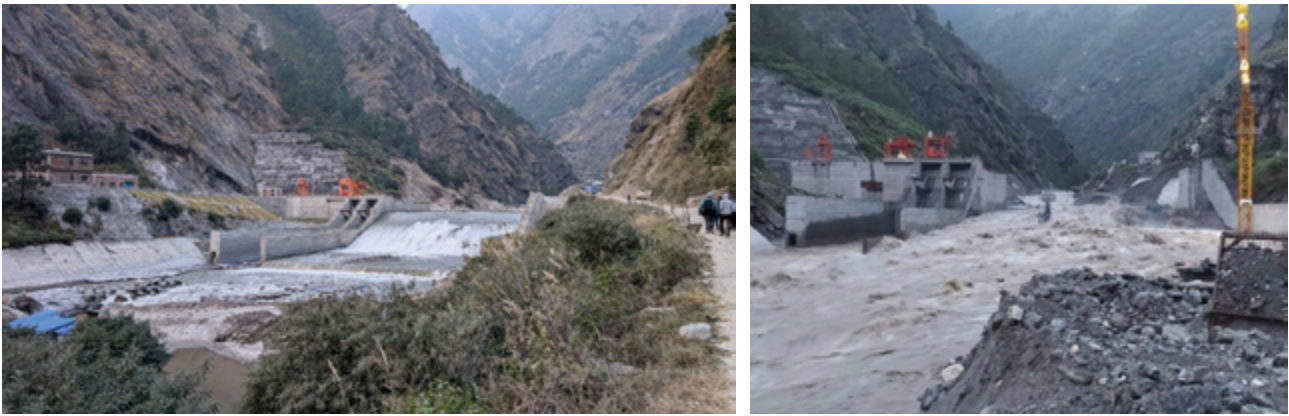
Figure 23: Before (November, 2024) and after (9 July 2025) photographs showing the Hydropower dam was completely collapse. (Photo by Sudan Bikash Maharjan (left) and online sources (right).)

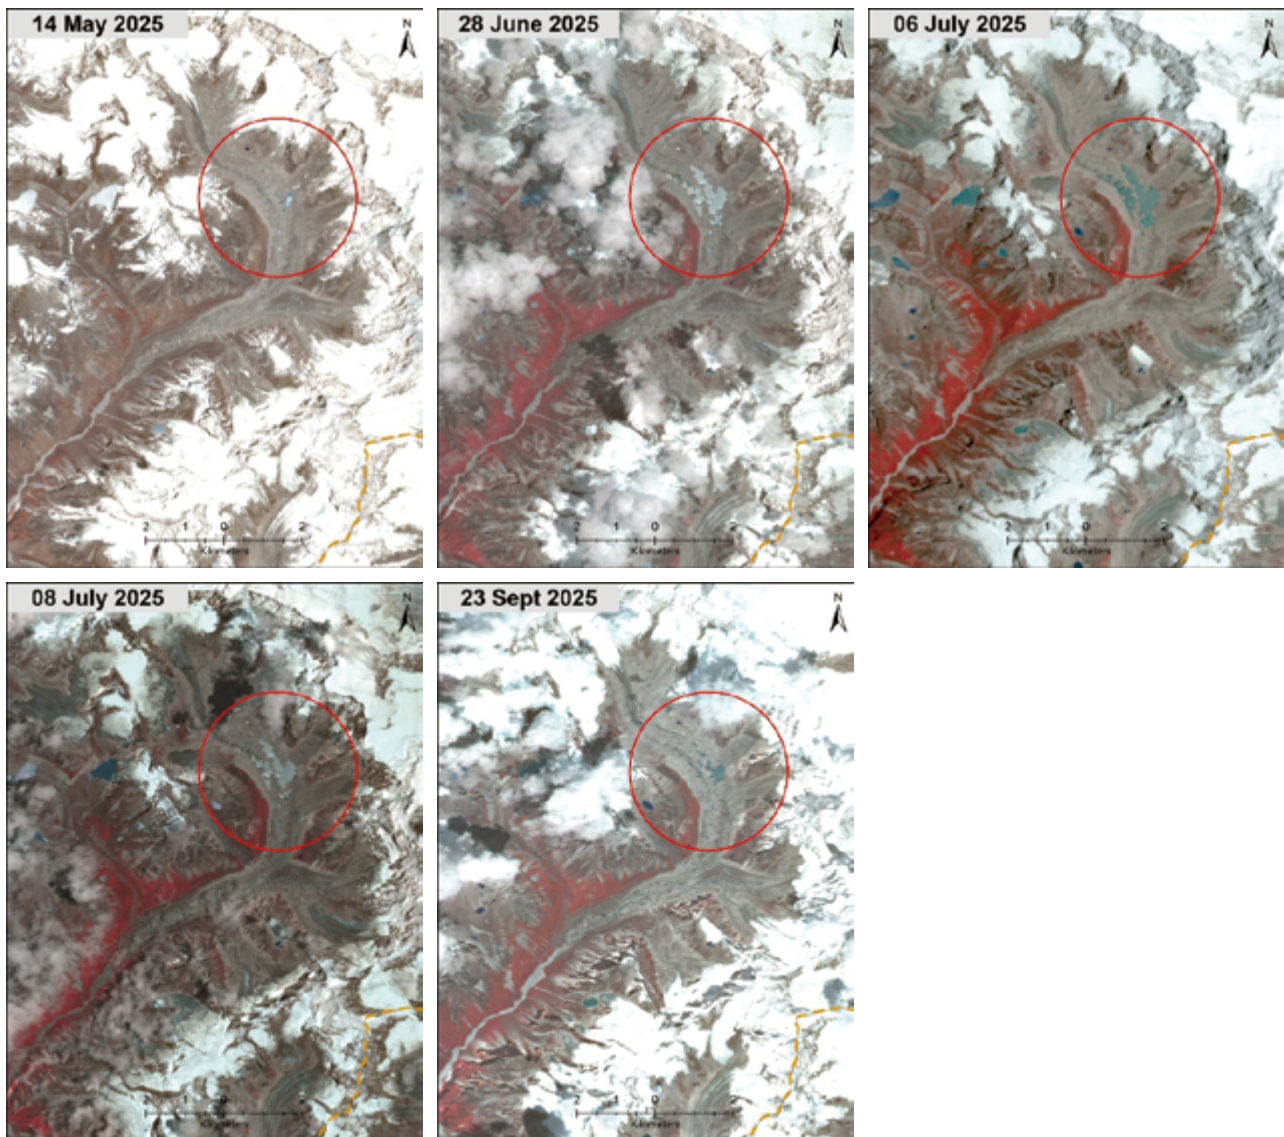
Figure 25: Time series of Sentinel-2 MSI imagery illustrating the rapid formation of a supraglacial lake on Perupu Glacier beginning in mid-May 2025 and drained on 8 July 2025. The 23 September 2025 image shows size of the lake had reduced significantly.
